# Structural integrity assessment of radioactive waste storage trenches at the Philippines' centralized radioactive waste management facility

This study evaluates the structural integrity of the reinforced concrete radioactive waste storage trenches (Trenches A, B, and C) at the Philippine Nuclear Research Institute (PNRI). Integrating non-destructive testing, destructive concrete coring, and ETABS dynamic modeling in accordance with the National Structural Code of the Philippines, the assessment revealed a severe, systemic degradation of the existing concrete matrix with a compressive strength of 12.77 MPa, below the 21 MPa seismic requirement. This material defect is responsible for various structural vulnerabilities, exposing a disconnect between the trenches' global geometric stiffness and their local member detailing. Structural analysis showed that Trench A failed drift checks, while Trenches B and C passed global drift checks but still exhibited localized member deficiencies. To mitigate radiological risk and align the facility with modern seismic standards, structural retrofitting is recommended, specifically utilizing reinforced concrete jacketing to restore column capaci

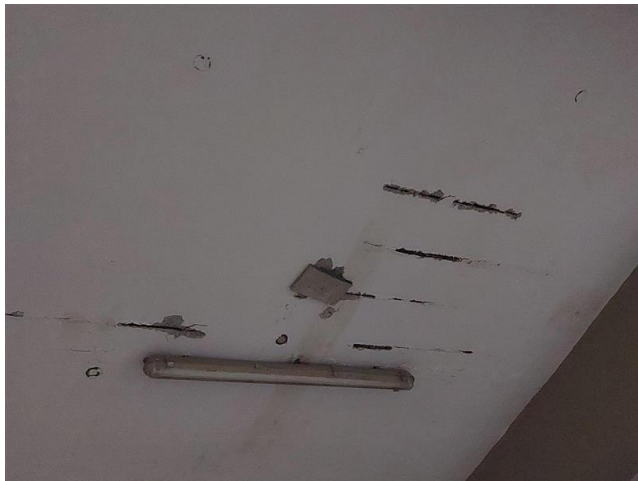
Detailed site investigations uncovered several localized and systemic physical defects across the facilities. It was observed that the concrete slab in Trench C lacks adequate concrete cover over its reinforcing steel (Figure 2). This exposes the rebars directly to environmental moisture, rapidly accelerating corrosion and inducing concrete spalling.

**Figure 2:** Exposed Reinforcement Bars under the Slab in Trench C.

As a more practical and cost-effective alternative, structural retrofitting is recommended to restore the strength, stiffness, and seismic performance of the existing trenches while maximizing the use of the remaining serviceable components of the structure. The assessment indicates that, despite the degraded concrete strength and inadequate member capacities, the existing structural system can still be rehabilitated through appropriate strengthening measures. These may include reinforced concrete jacketing of columns to improve axial, flexural, and shear capacities, enhancement of critical structural members to address identified demand-capacity deficiencies, and strengthening of the roof diaphragm using Carbon Fiber Reinforced Polymer (CFRP) systems or other suitable technologies to improve load transfer and seismic performance.

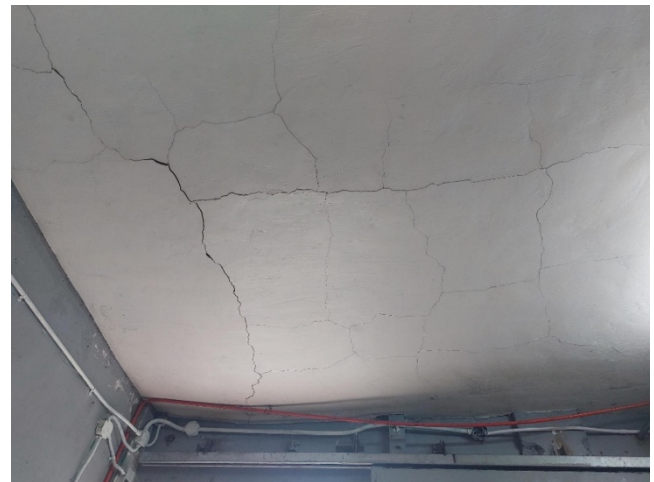
Initial observations noted major cracking and deflection on the roof slab and ceilings of Trench B (Figure 3). The exposed slabs present major vulnerabilities due to inadequate capacity to carry additional finishing and truss loads.

**Figure 3:** Cracks Formed under the Slab of Trench B.

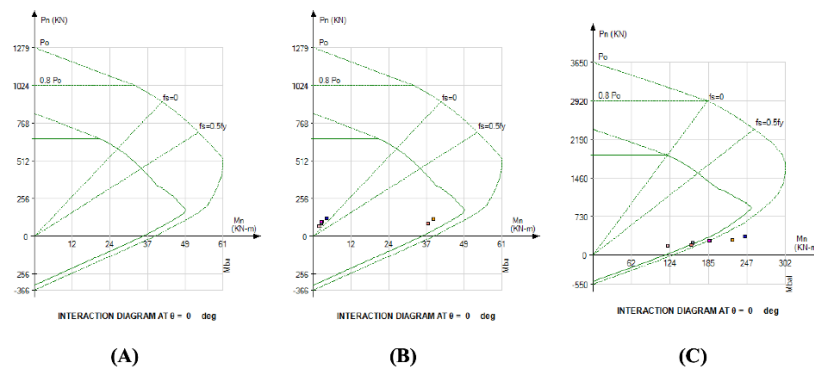
Trench A is characterized by a critical lack of lateral stiffness, as already proved by its global drift check (Table 9). Because the building is highly flexible, it experiences massive horizontal swaying during a seismic event. The gravity loads acting on the deflected columns induce severe secondary moments when the structure sways excessively. Given the low concrete strength and the lack of structural rigidity, the columns in Trench A are highly susceptible to global buckling.

Trench B, on the other hand, successfully passed its global drift checks indicating that its structural frame is stiff, with a 0.86 moment capacity ratio (Table 10). However, because the structure is adequately stiff and does not sway excessively, the columns must absorb the full vertical gravity load without the relief of structural yielding. The degraded concrete capacity makes these columns highly susceptible to pure axial crushing.

Trench C is the stiffest facility with the lowest period of 0.39 seconds but recorded widespread column moment capacity failures. With the already low concrete capacity of 12.77 MPa, the concrete column lacks the capacity to resist seismic forces making it susceptible to shear failures. The column also exceeds the axial-moment interaction limits (Figure 4C) wherein there is no capacity to resist combined stresses leading to simultaneous crushing and flexural yielding.

**Figure 4:** Column Interaction Diagrams for (A) Trench A, (B) Trench B, and (C) Trench C (ITC Corp 2025).

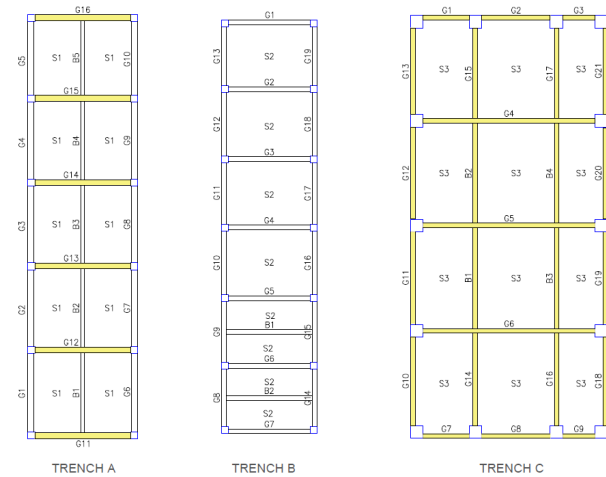
The beams, responsible for gathering roof loads and resisting flexure, exhibited varying degrees of failure across the trenches. Trench A demonstrated widespread capacity and deflection failures in the consultant analysis, with the affected beam members identified in Figure 5. Trench B beams passed the reported capacity and deflection checks. Trench C beams generally passed ultimate capacity checks but did not satisfy the reported deflection limits.

**Figure 5:** Failed Beam Members (Highlighted in Yellow).
